Condition Assessment Report

Denny Sanford Premier
Center
Sioux Falls, South Dakota
5 January 2018

SGH Project 171728

Project 171728 – IMETCO CF-12 Flush Metal Panel Assessment, Denny Sanford Premier Center, Sioux Falls, SD

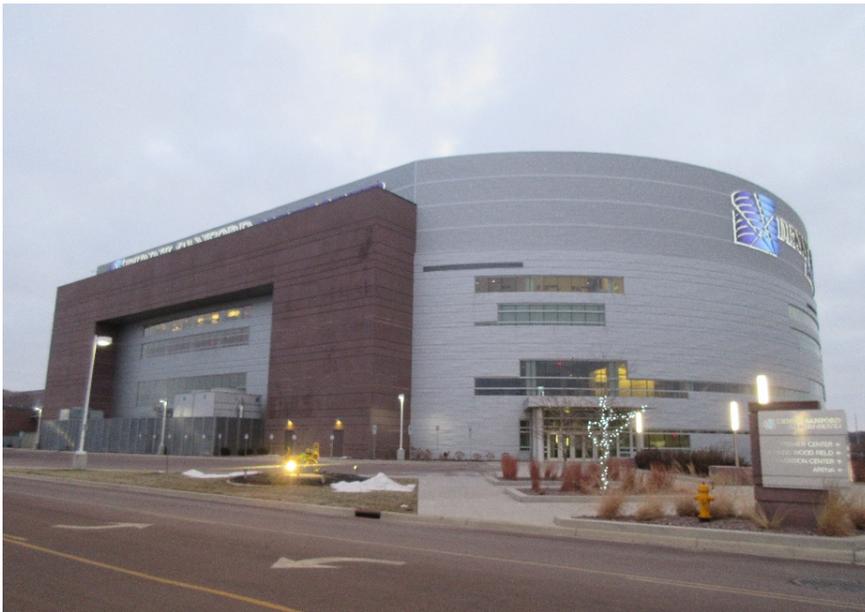
Photo 1

Overall view of north elevation.

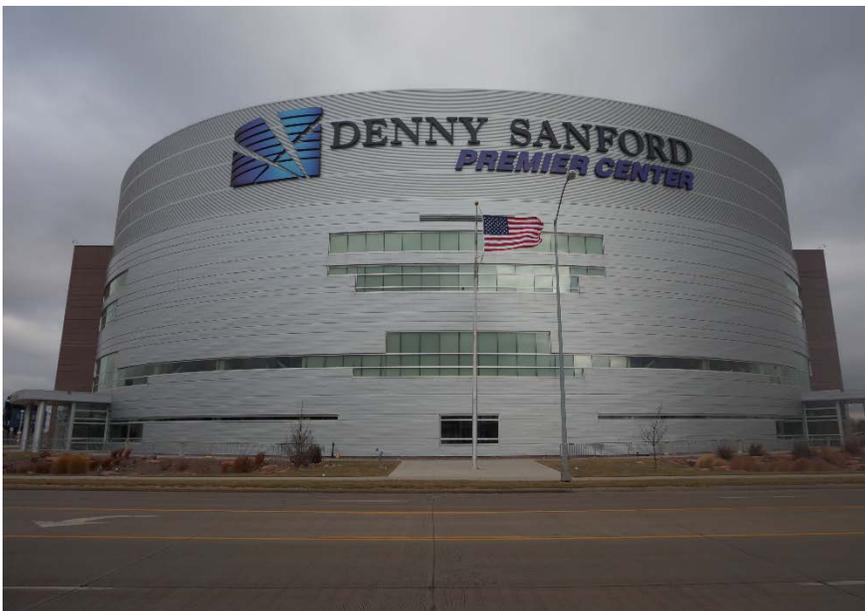
Photo 2

Overall view of west curved elevation.

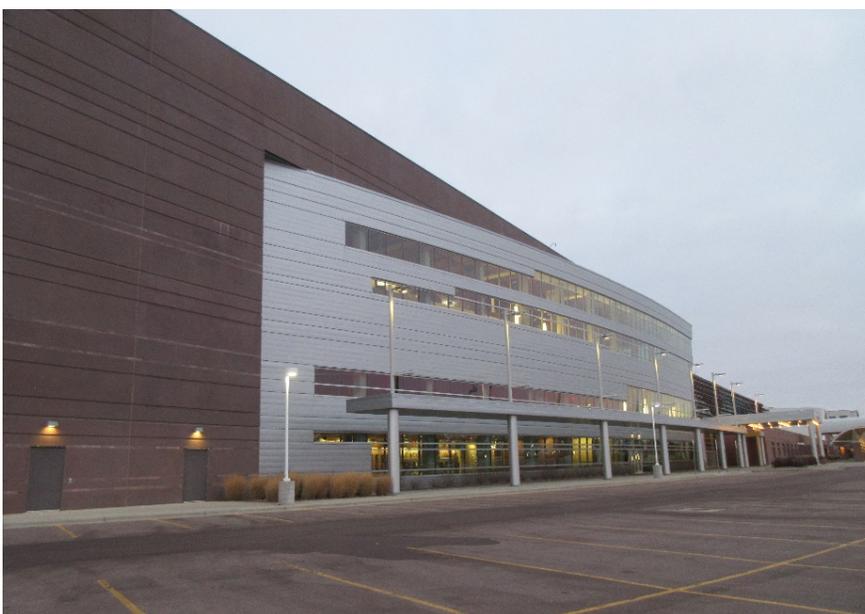
Photo 3

Overall view of south elevation.

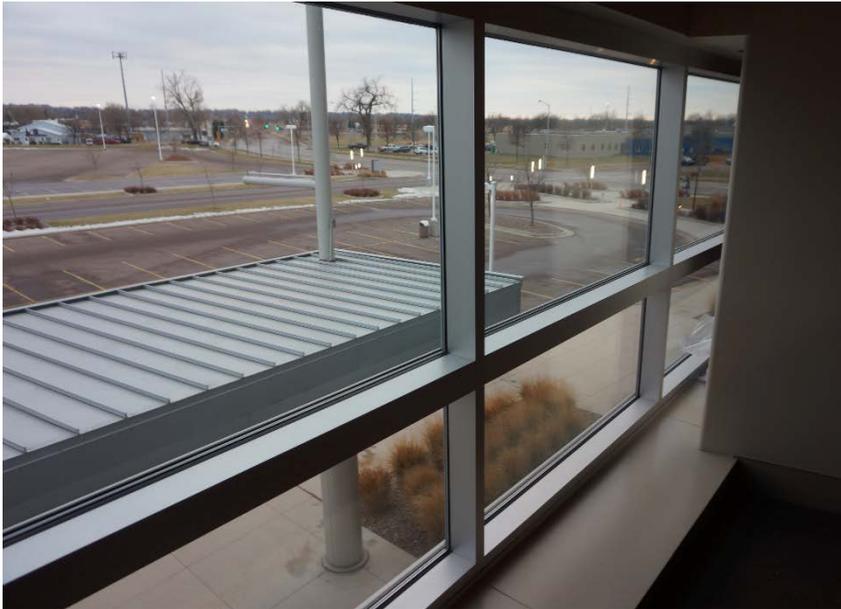
Photo 4

View of the aluminum-framed glazing system from the interior.

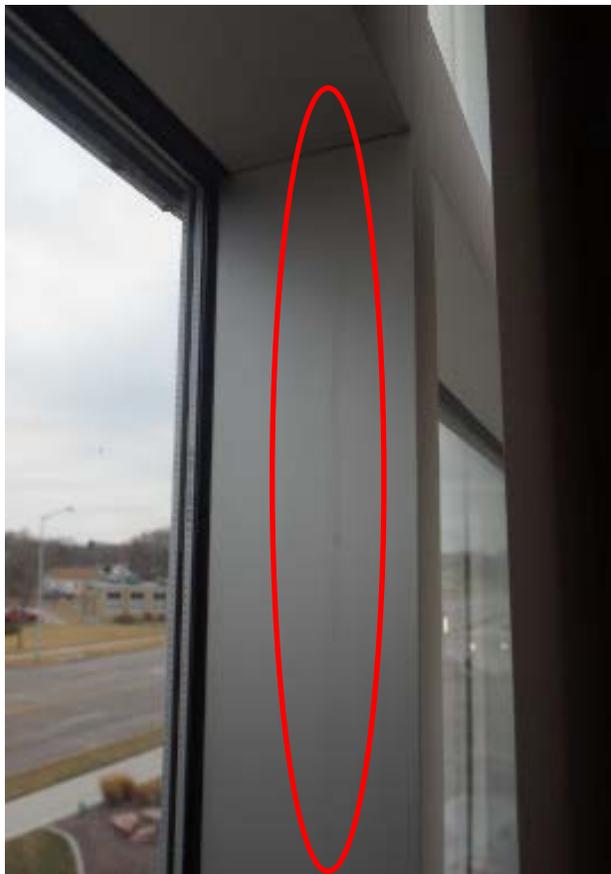
Photo 5

Streaking on the vertical mullions.

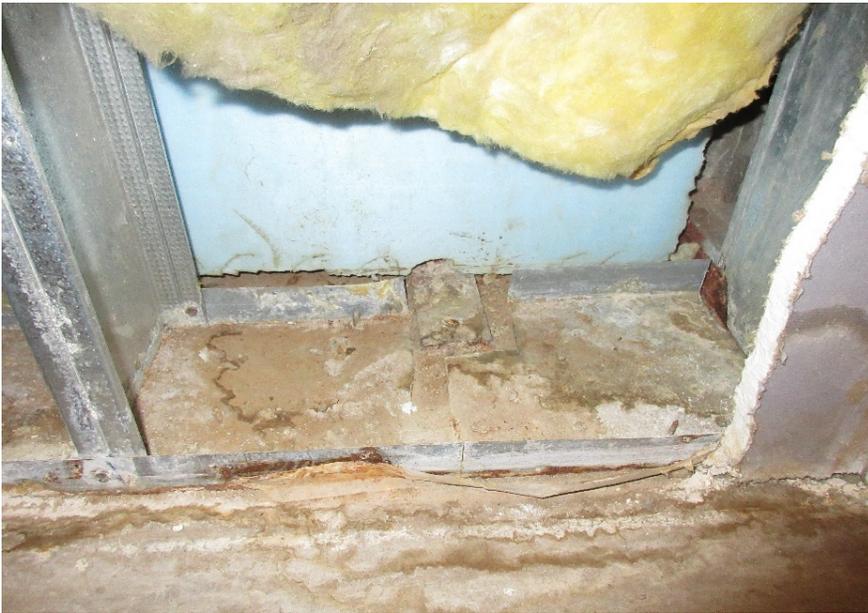
Photo 6

- We did not observe any signs of water leakage into the building through the opaque wall system supporting the flush metal panels. We note that there was no precipitation during or surrounding the time of our site visit.
- The aluminum-framed glazing system is made up of thin vertical mullions 1-3/4 in. wide and horizontal mullions 3-1/2 in. wide, with a depth of 4-1/2 in. (Photo 4).
- We observed water streaks on the vertical mullions (Photo 5).
- At the reported leak location in the mechanical room, the exterior wall remained open from the moisture investigation. From the opened wall we observed 6 in. deep steel studs, spaced approximately 18 in. on center, with batt insulation filling the cavity. We also observed rigid board insulation 1-1/2 in. outboard of the studs (air space in between). We did not observe any moisture in the cavity at the time of inspection (Photo 6).

Sample opening in mechanical room wall at location where moisture was observed.

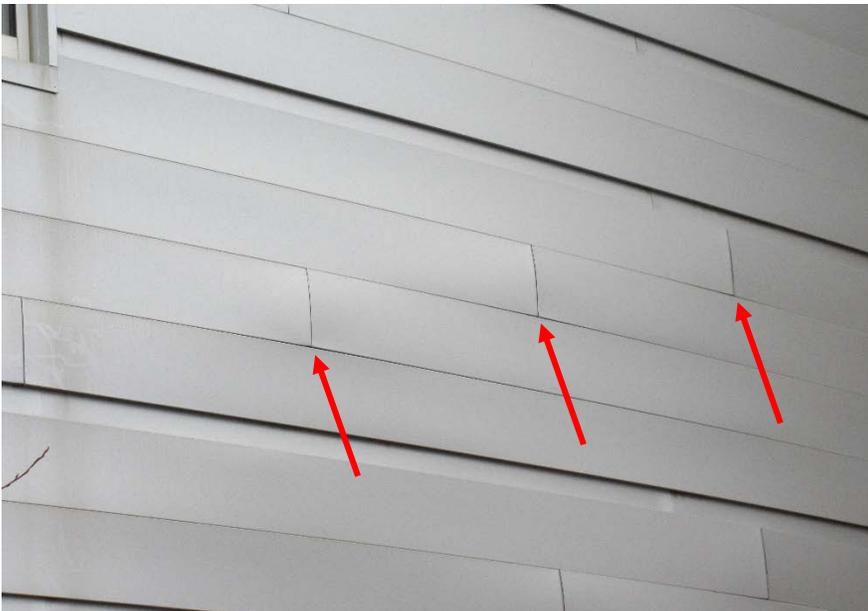
Photo 7

Pattern of visible change at panel-to-panel end joints.

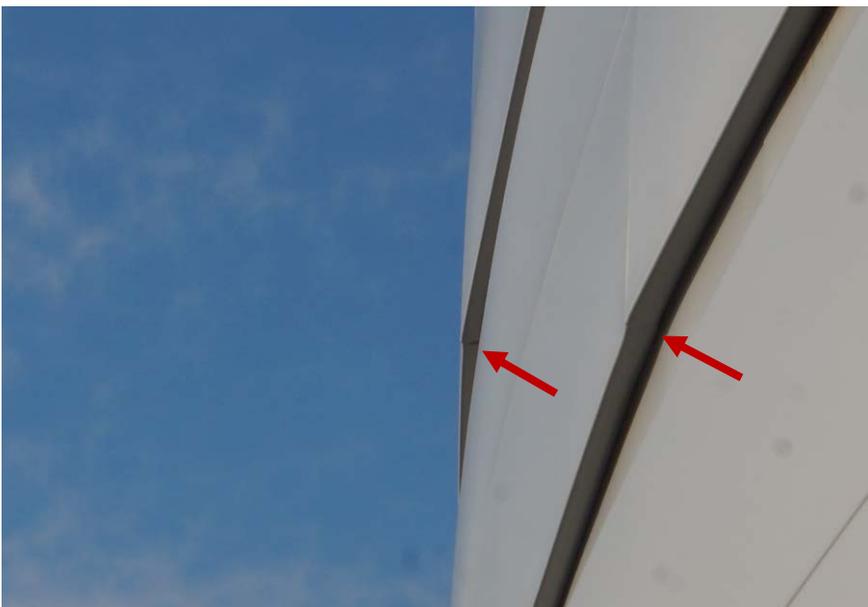
Photo 8

Panel end joints protrude from the plane of adjacent panels.

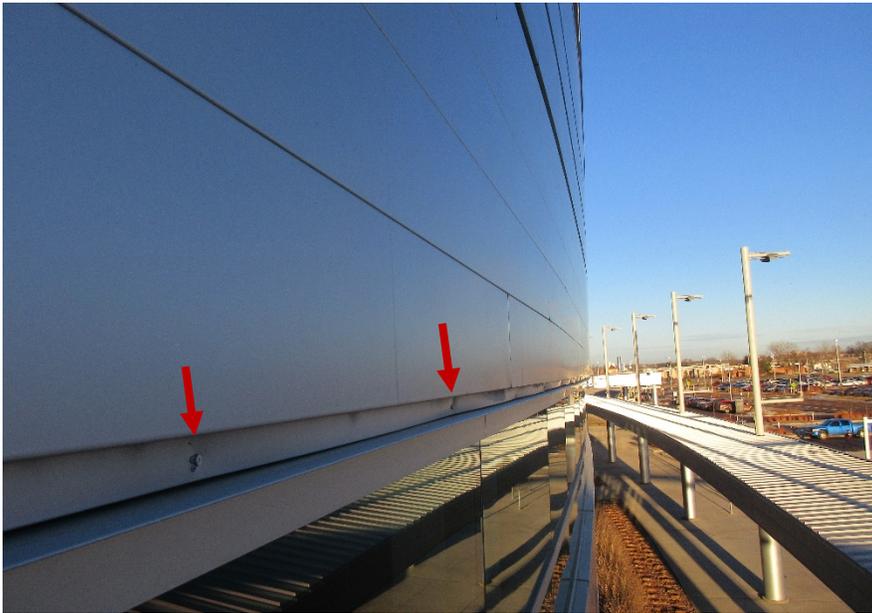
Photo 9

- The locations of fasteners attaching the metal panel to the furring are not readily observable. On the south elevation, we observed a location where the window head flashing is missing, exposing the metal panel fasteners (Photo 9). The measured spacing was approximately 3 ft on center.

Exposed fasteners at window head.

- One window head trim piece is missing on the south elevation. We recommend replacing this component to complete the assembly, cover the exposed fasteners, and standardize the visual appearance of this area.

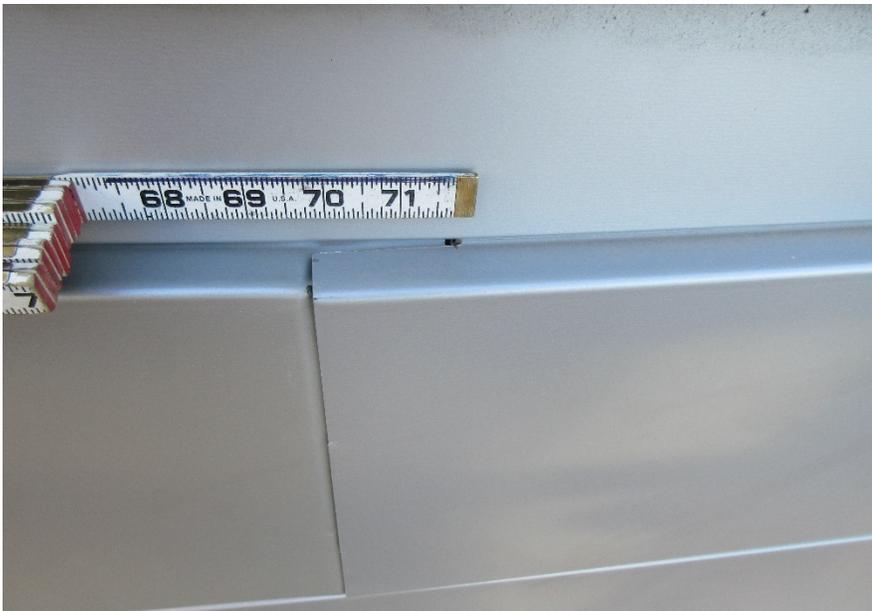
Photo 10

Panel-to-panel end joint overlap.

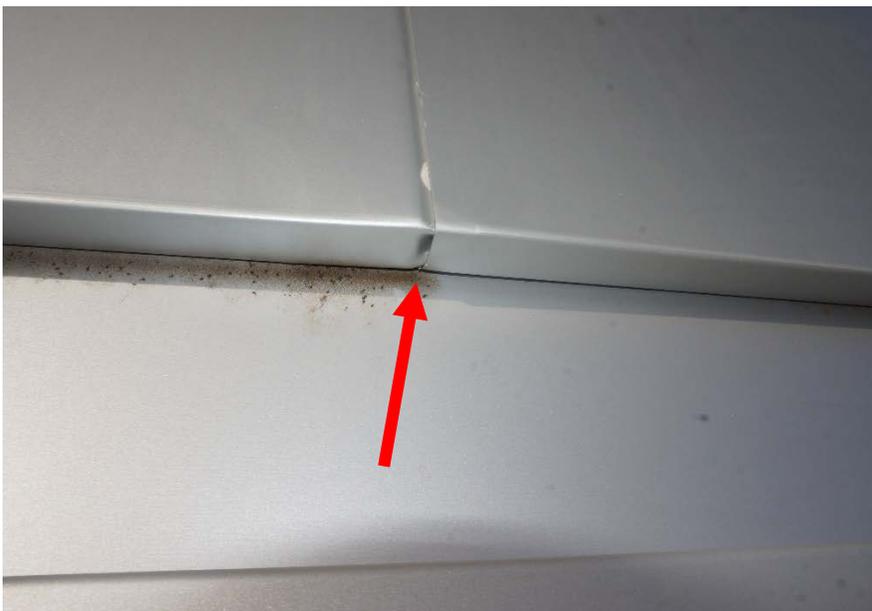
Photo 11

View of swaged panel (left) inserted behind the lapping panel.

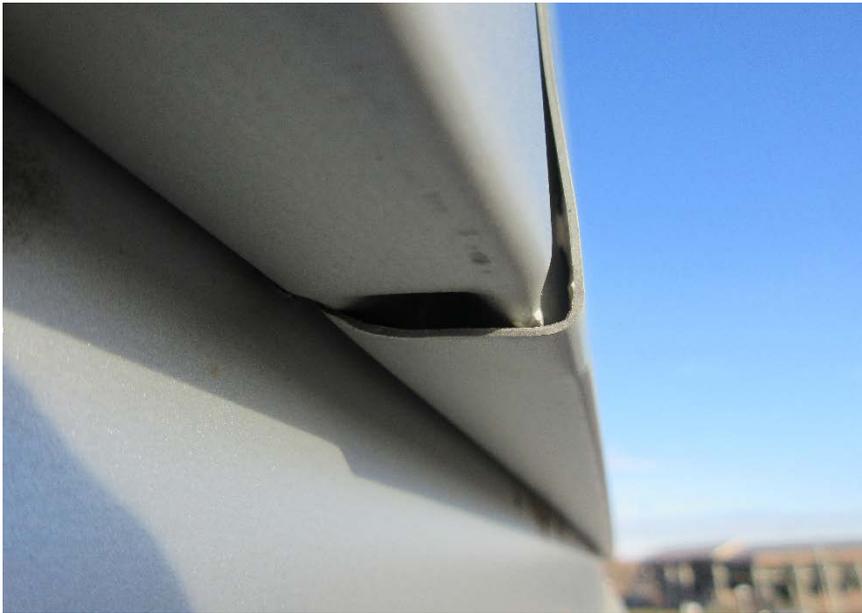
Photo 12

Inner panel swaged to fit within outer panel. Outer panel protrudes slightly to accommodate inner panel.

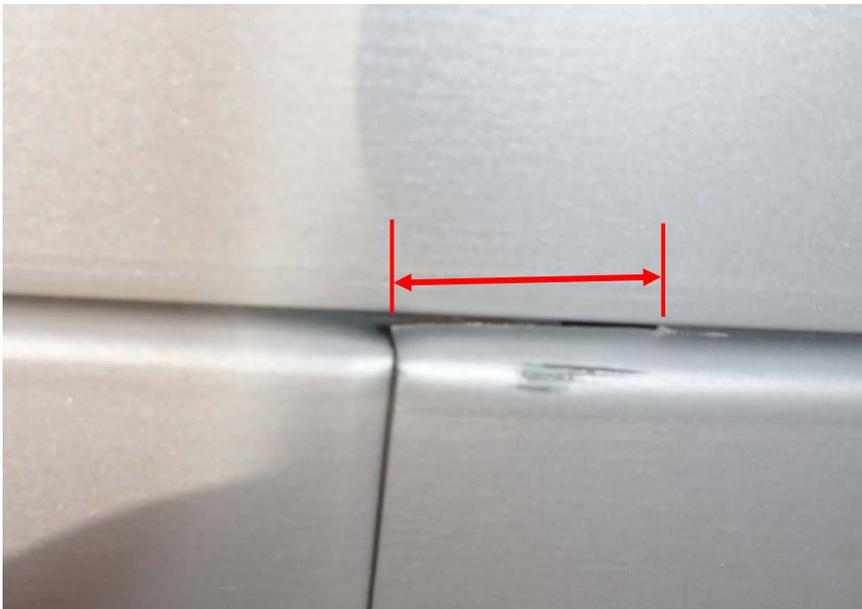
Photo 13

Lapping panel has been cut back to accommodate the swaged panel behind.

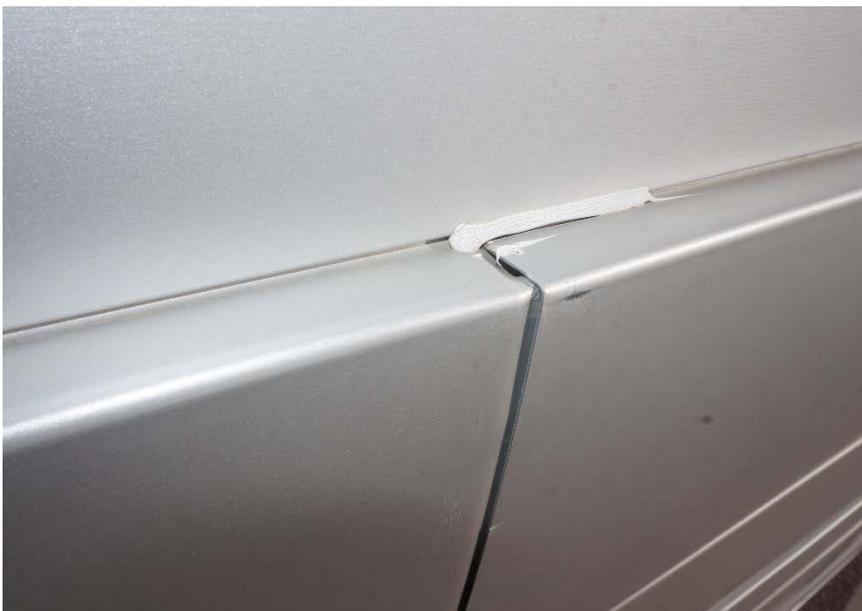
Photo 14

Sealant applied over notched gap in panels.

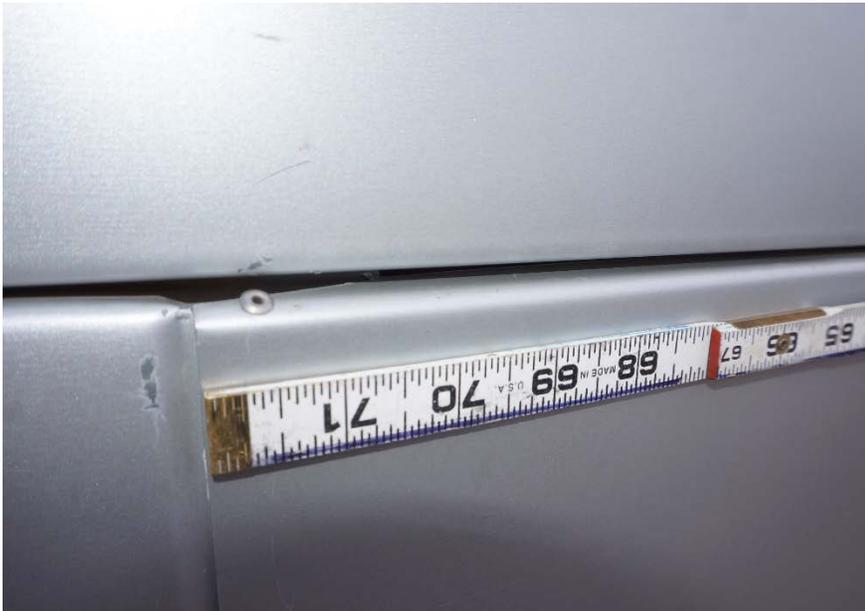
Photo 15

One lapped panel flange we observed is cut back more than 6 in. There is a rivet installed at the joint.

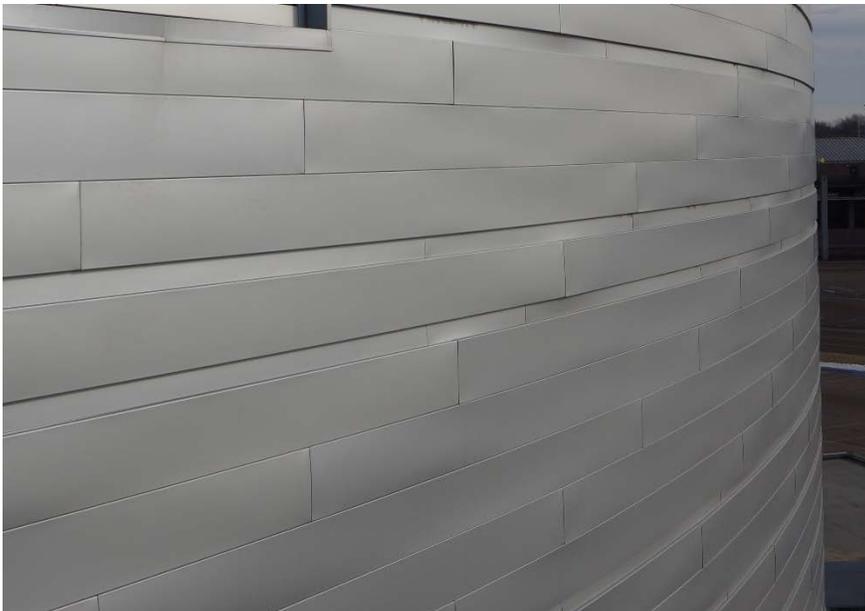
Photo 16

Observable variations in gaps and bulges at panel-to-panel end joints.

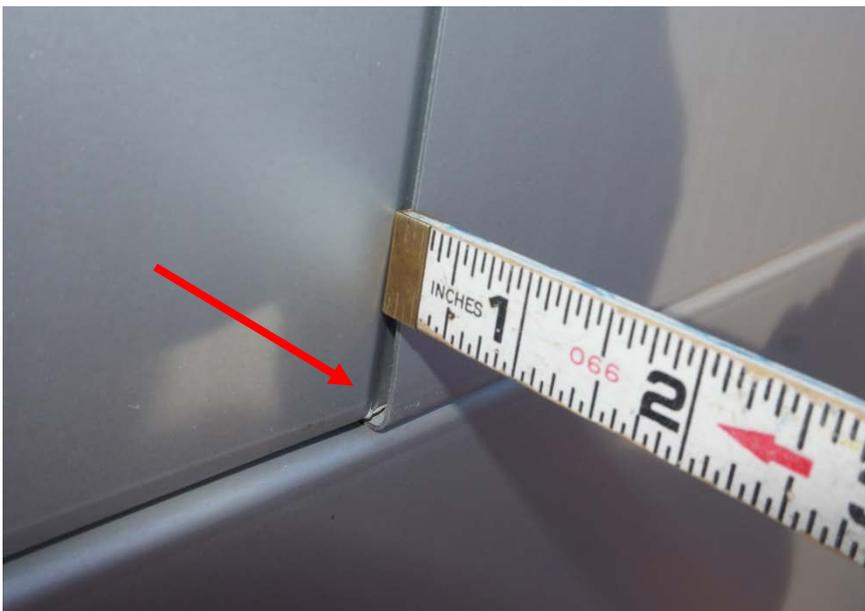
Photo 17

Bulging at bottom of outer panel due to end lap treatment.

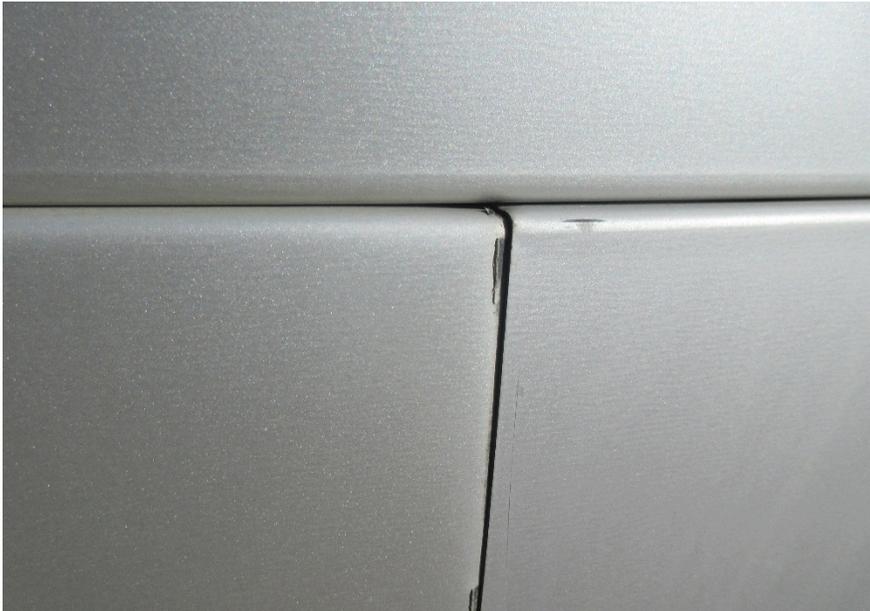
Photo 18

Paint scraped off metal panel at end joint.

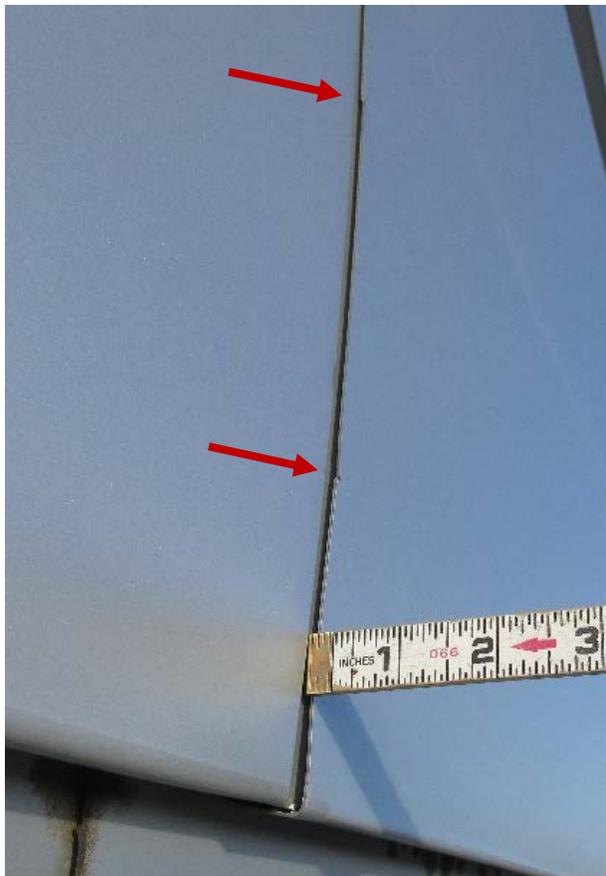
Photo 19

Outer panel appears to be cut at the joint with no finish at the cut edge, with two perpendicular nicks.

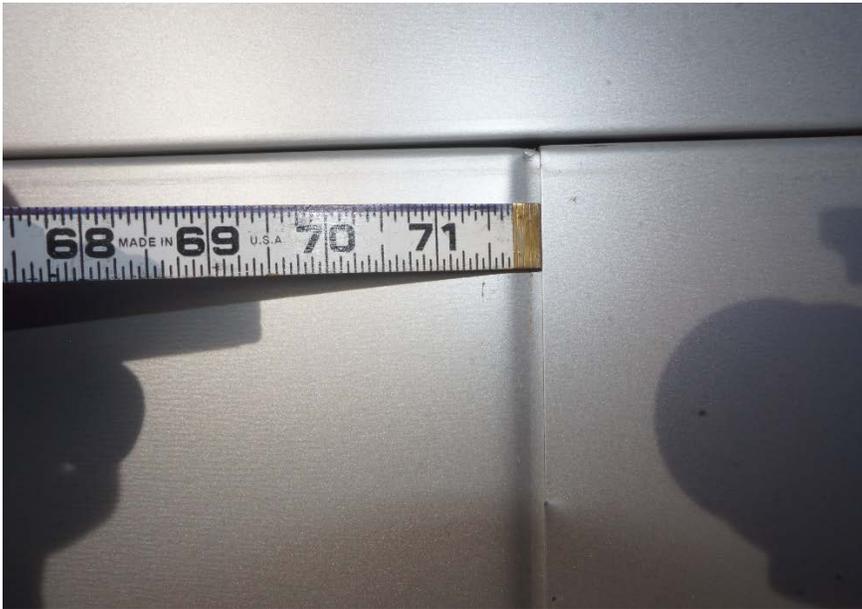
Photo 20

Measurements of end joint widths.

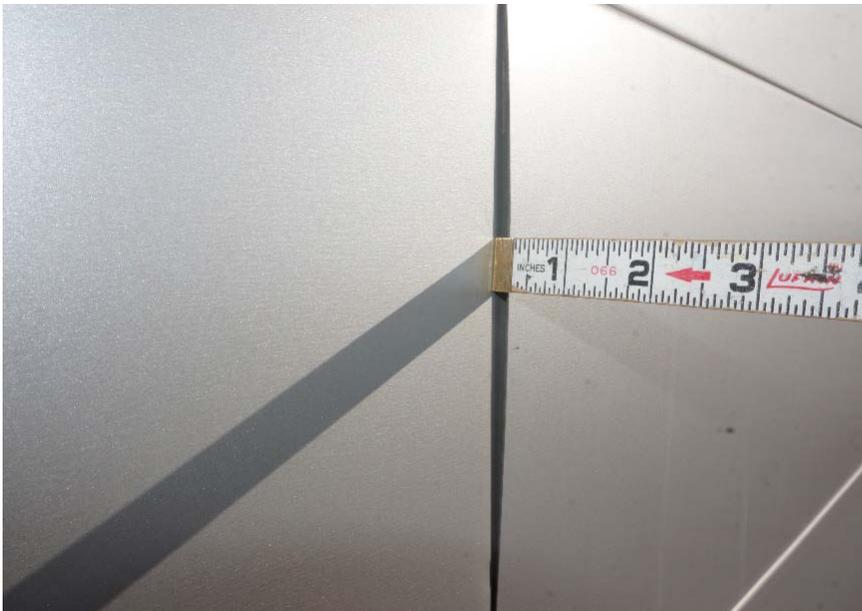
Photo 21

Measurements of end joint widths.

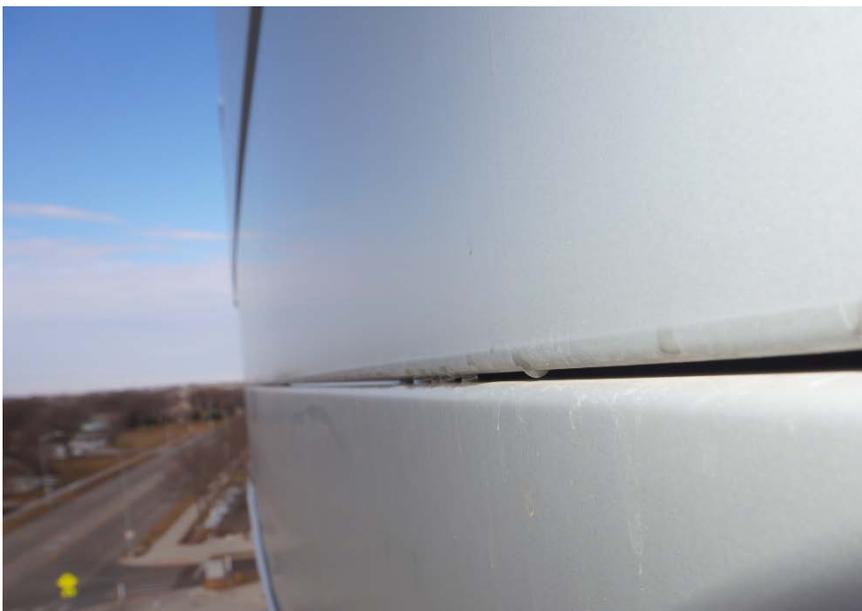
Photo 22

- We observed water collecting within the longitudinal joint opening at one location (Photo 22)
 - We took measurements of twenty longitudinal metal panel joints throughout the building, recording the in-plane dimension between adjacent panels (Photo 23). The joint gap is difficult to measure because of the radiused bends in the panel, but we observed that the gap typically varied from 1/32 in. to 1/16 in., but many locations are butted up against each other such that a credit card cannot be slid into the gap.

Water collecting within the longitudinal joint opening.

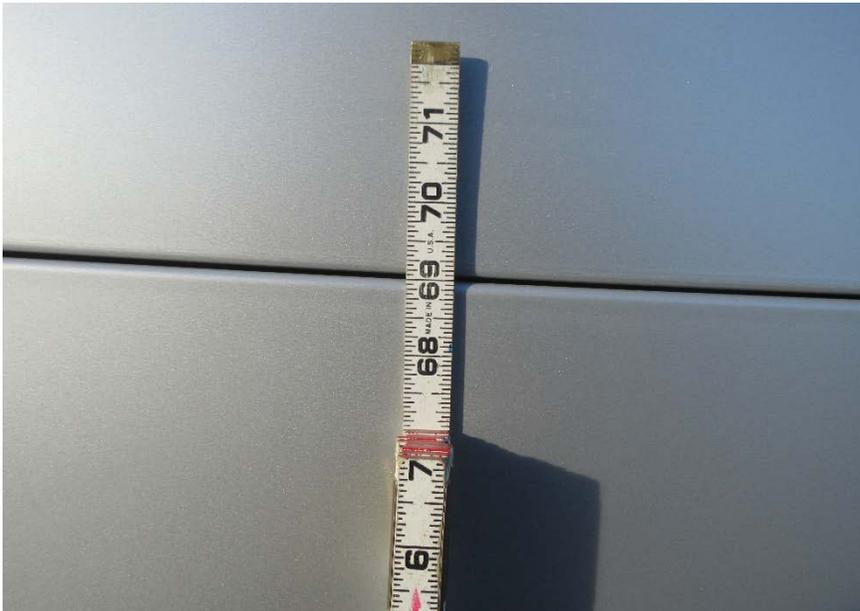
Photo 23

Measurement of horizontal joint.

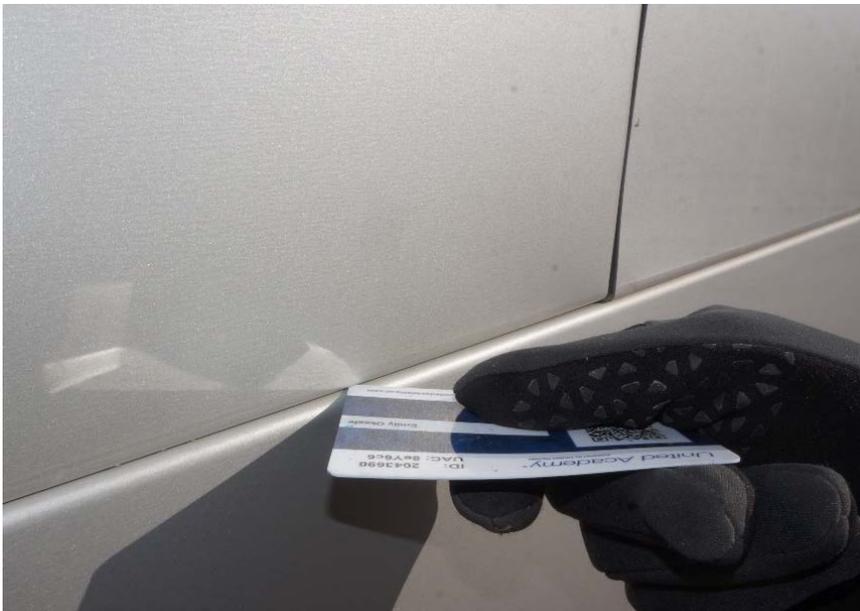
Photo 24

- We observed that these tight gaps often correspond to locations where there is buckling in the adjacent panels (Photo 24).
 - We performed qualitative pull tests on twenty-six metal panels throughout the building with a suction cup. Our testing found that the panels appear to be securely attached to the substructure with fasteners and properly interlocked with the surrounding panels (Photo 25).

Example of tight horizontal joint where a card (< 1/32 in.) could not fit in the gap.

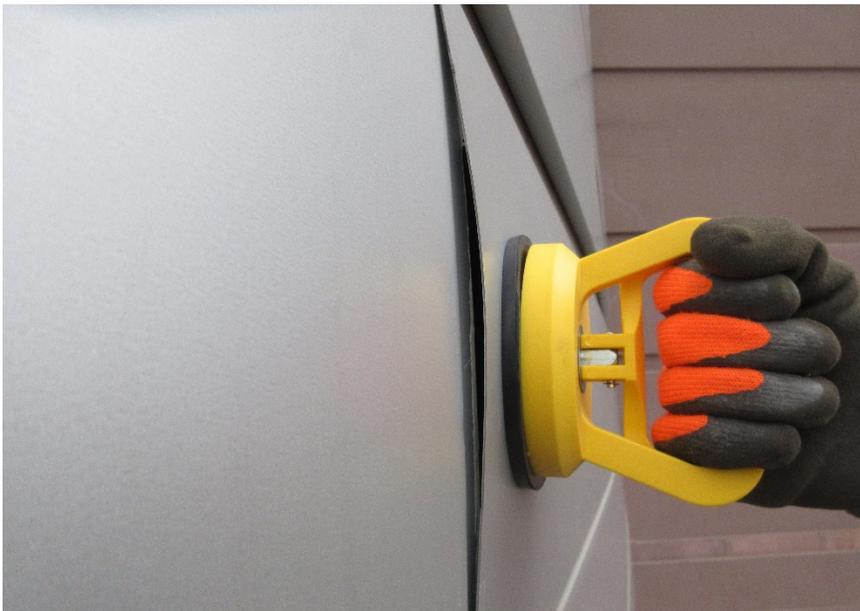
Photo 25

Pull test of metal panel.

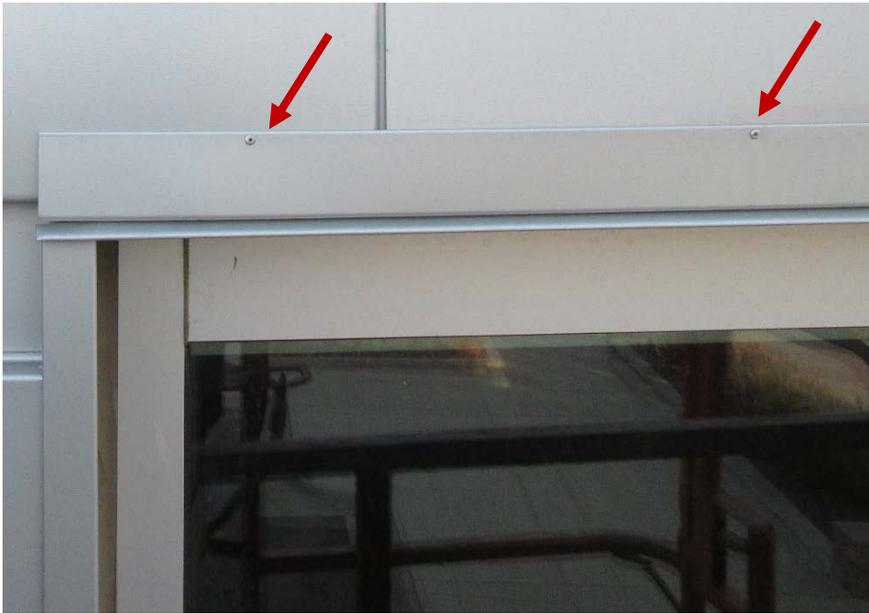
Photo 26

- The metal panel trim at sills, jambs, and building corners is typically riveted to the metal panels (Photo 26).
 - We observed one rivet pulled through the steel trim at the window head on the third floor on the curved west elevation (Photo 27), leaving this portion of the panel loose.

Metal panel trim at head is riveted into the metal panels behind.

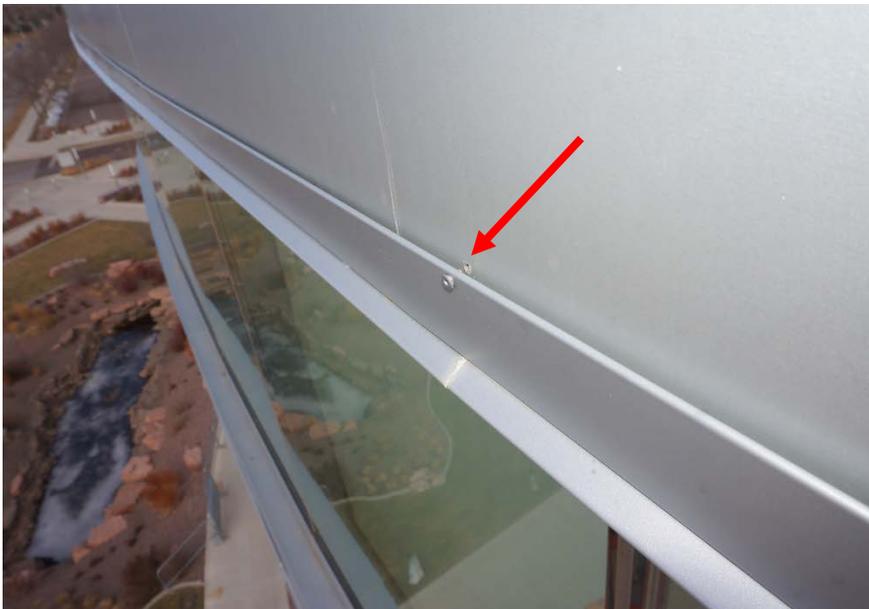
Photo 27

We noted isolated cases of metal trim rivets which are pulled through the metal trim or metal panel cladding behind (Photo 27 and 28). Additionally, we observed isolated locations of loose bent metal trim at window jambs. We recommend that these pieces be attached or reattached and that the building be monitored annually for any trim that appears loose or poorly attached.

Rivet that has pulled through the steel trim at the window head on the third floor on the west curved elevation.

- Loose trim components need to be secured to the building. Inspect the building trim to identify issues with the attachment, set in sealant and mechanically attach with rivets or screws, if necessary.

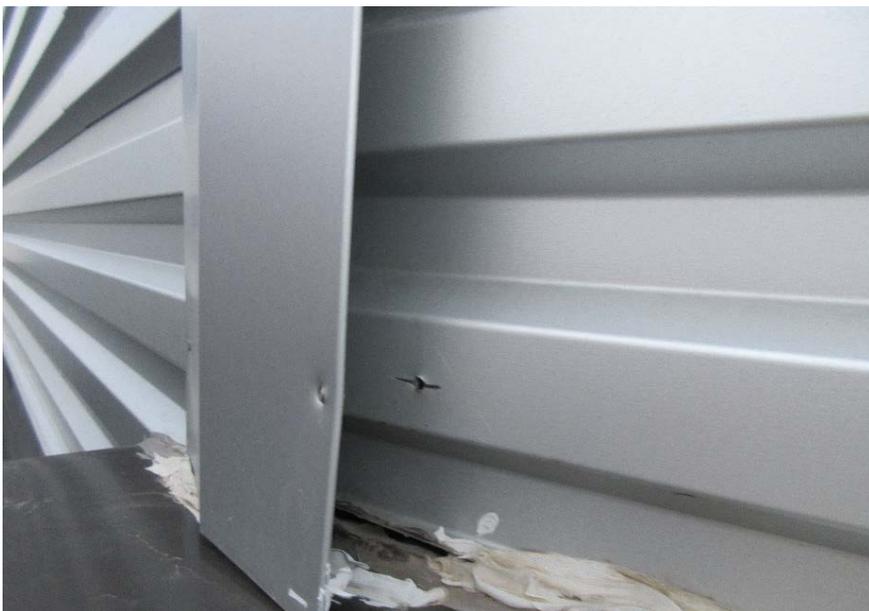
Photo 28

- The corner trim piece at the southeast corner of the corrugated metal panel cladding system is attached with rivets. A number of the rivets are pulled through either the front or back piece of metal, or appear to have never engaged both pieces (Photo 28).
- We observed two different methods of treating metal panel reveals where they terminate at window jambs. The most common is a fillet joint of sealant from the metal panel to the window jamb trim (Photo 29). At isolated locations, on the lower two levels of windows, a bent piece of trim is slid into the gap. The trim is typically loose and does not appear to be attached to the adjacent cladding in any way (Photo 30).
- At isolated areas of the reveals, we observed a dark stain emanating from the top of the reveal along an area several inches to several feet long (Photo 31).

Corner trim piece on the southeast corner pulled through the rivets that attached in to the corrugated panels on the east side.

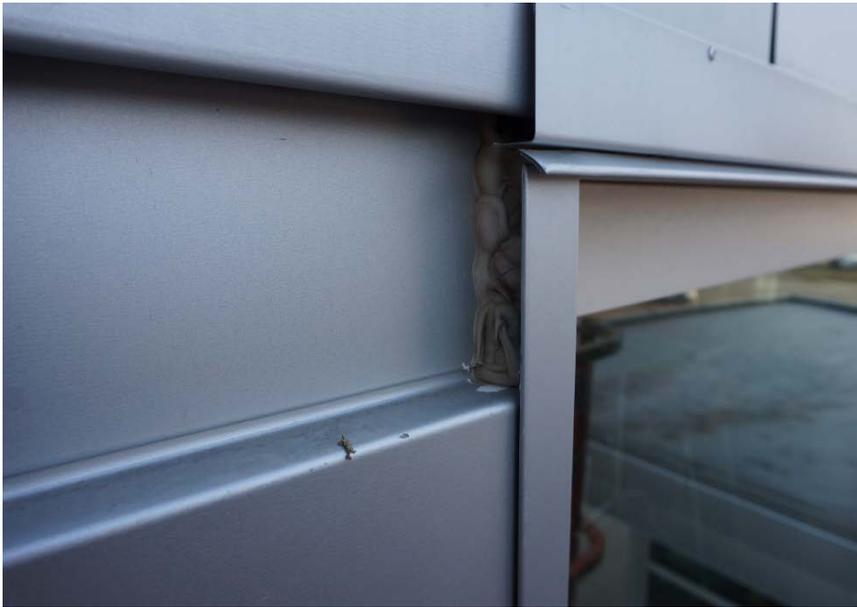
Photo 29

Gap between window jamb trim and reveal panel filled with sealant.

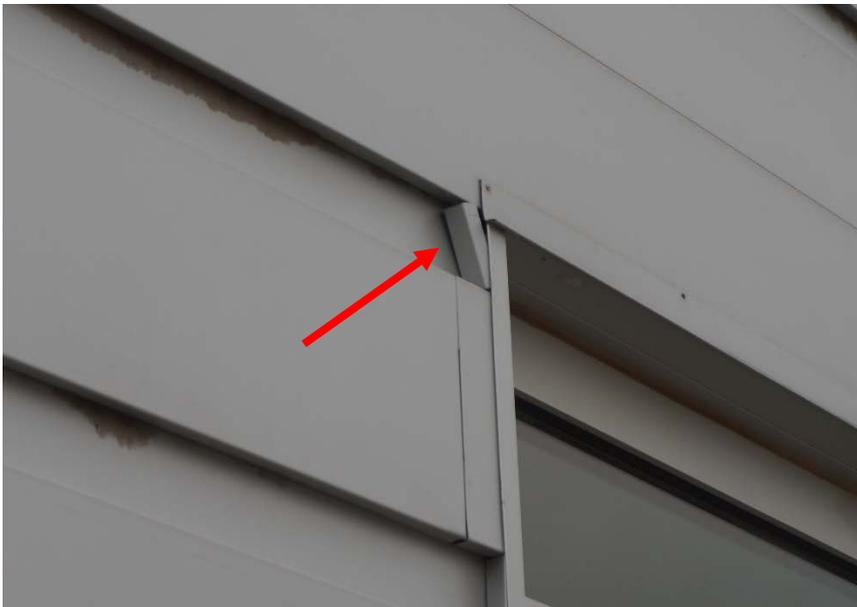
Photo 30

Trim cover piece between the window jamb and reveal panel is loose.

- The bent trim pieces between the window jamb and the reveal panels do not appear to be secured to the wall in any way, and at least three are visibly loose. We recommend that these pieces be removed and reattached by riveting them to the window jamb trim or by setting them in silicone to prevent future falling hazards.

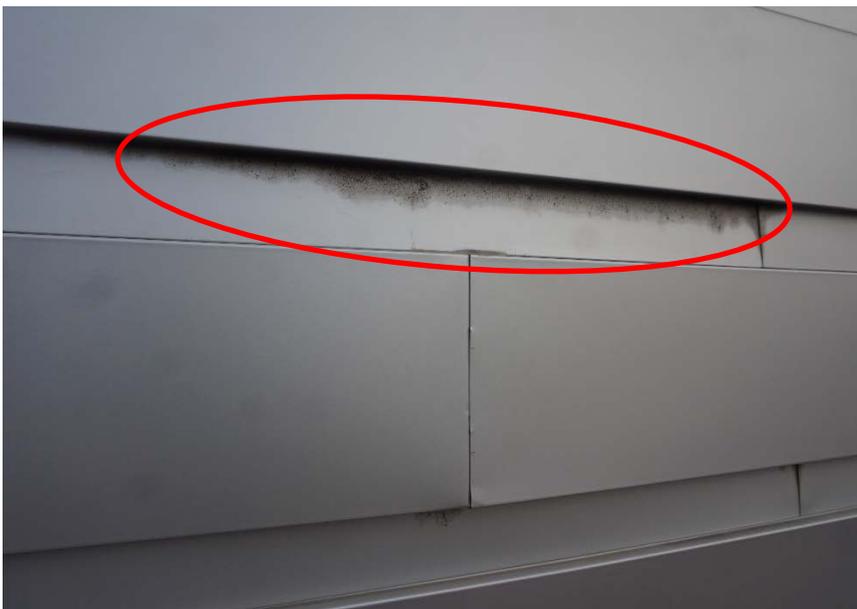
Photo 31

- We observed dark staining on the face of the reveal panels, typically originating at the top. As discussed in the documents provided, the staining is likely due to residue from the butyl sealant used in panel joints, which has not washed off the panels. We recommend scraping and washing this off the panels, as described in the IMETCO email, and monitoring for reoccurrence.

Staining on metal reveal panels throughout the building.
