## **Falls Park Loss Control Special Review June 18, 2018**

This report follows the drowning on March 18, 2018, of a five-year-old girl, M.Z., at Falls Park. It presents the steps taken by the City of Sioux Falls to review the incident; the response of law enforcement and other City personnel; previous risk-management reviews and changes; and a discussion of options and recommendations for additional changes to manage the drowning risks inherent at Falls Park.

# Falls Park - Lower Falls Viewing

## EXHIBIT A

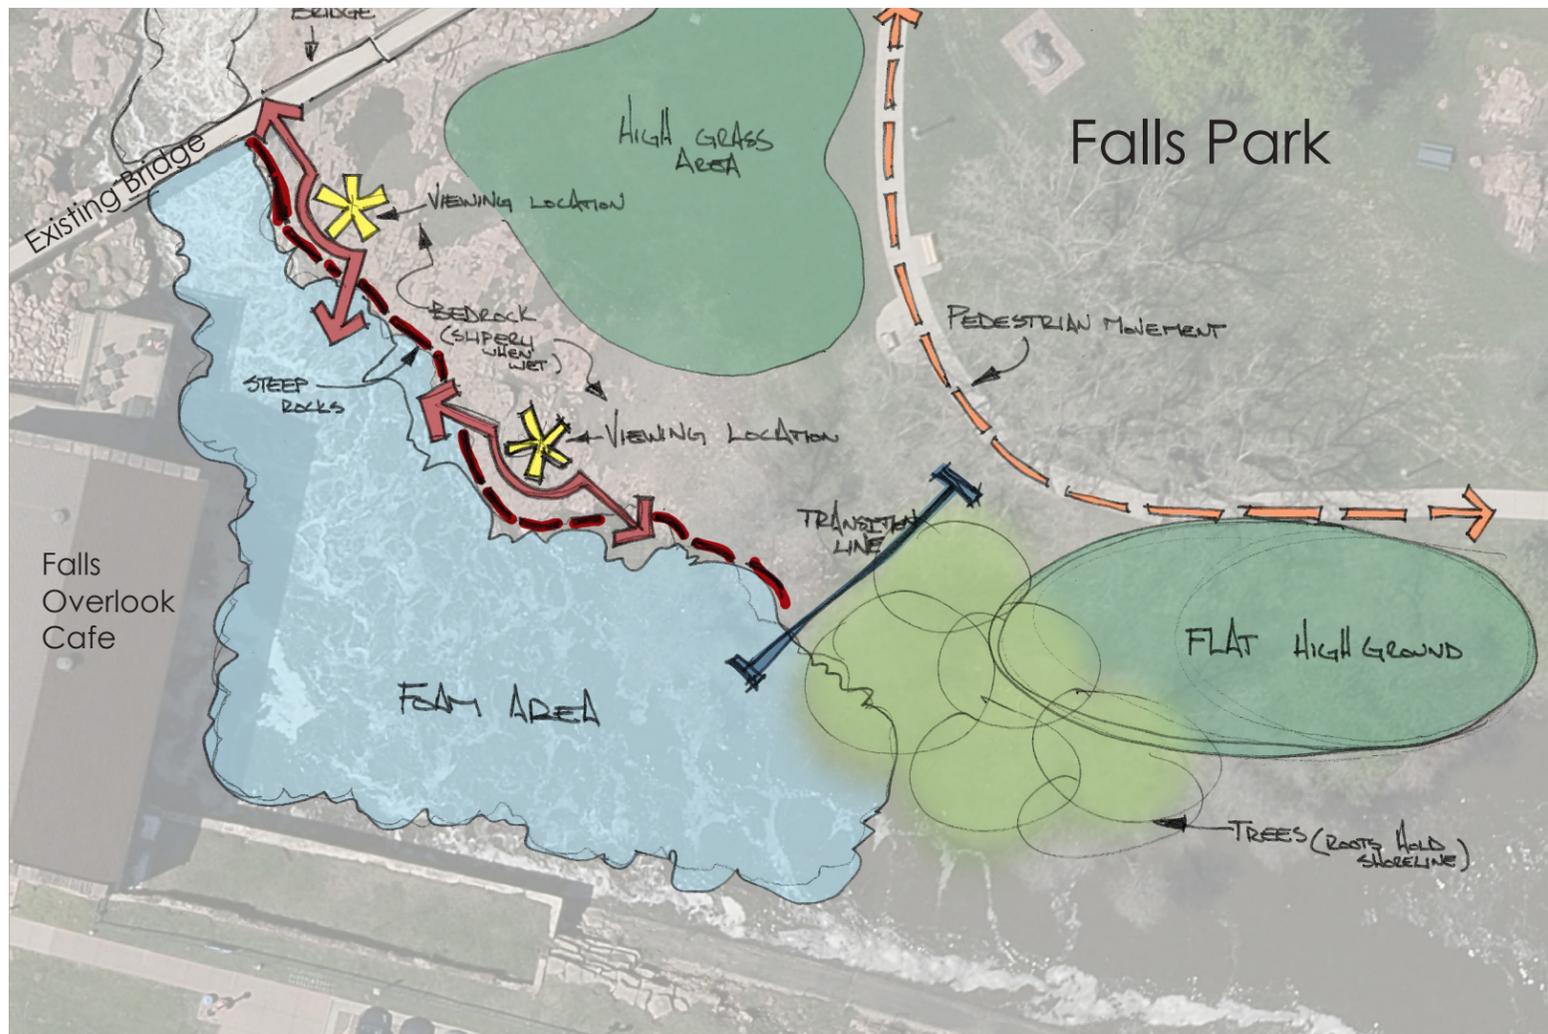
Approximate foam height

Bedrock is very slippery when wet

Steep drop off at river's edge

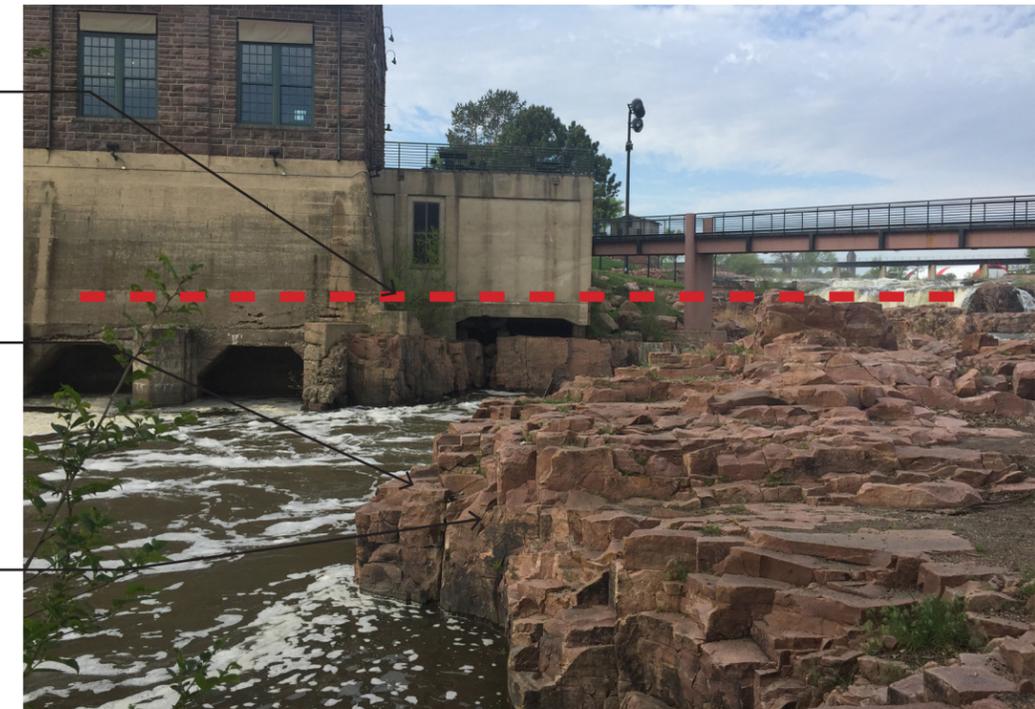
View of the South Area (bedrock area)

Flat grass area on top

Dirt side slope (trees holding bank)

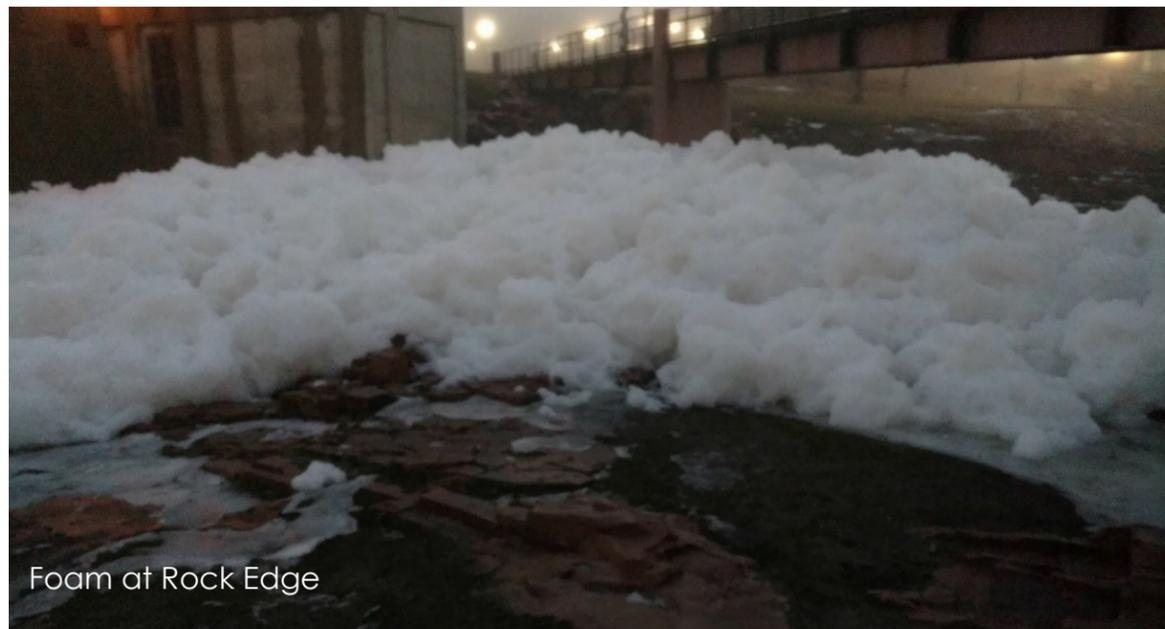
Foam at Rock Edge

The drowning on March 18, 2018, revealed the need to address the risk created by the build-up of foam in the river upstream from the pedestrian bridge and the Overlook Café. It is clear from the incident reports that M.Z. and others that day were attracted to the foam and that it obscured the edge of the rocks in relation to the river, including the steep drop. As noted on existing signage, the rocks are slippery when wet. Foam builds up naturally at that location at certain times when the water flow is greater and the river more turbulent. The existing site conditions are shown on the drawing and photographs marked as Exhibit A. There are several methods of managing the risk the foam presents.

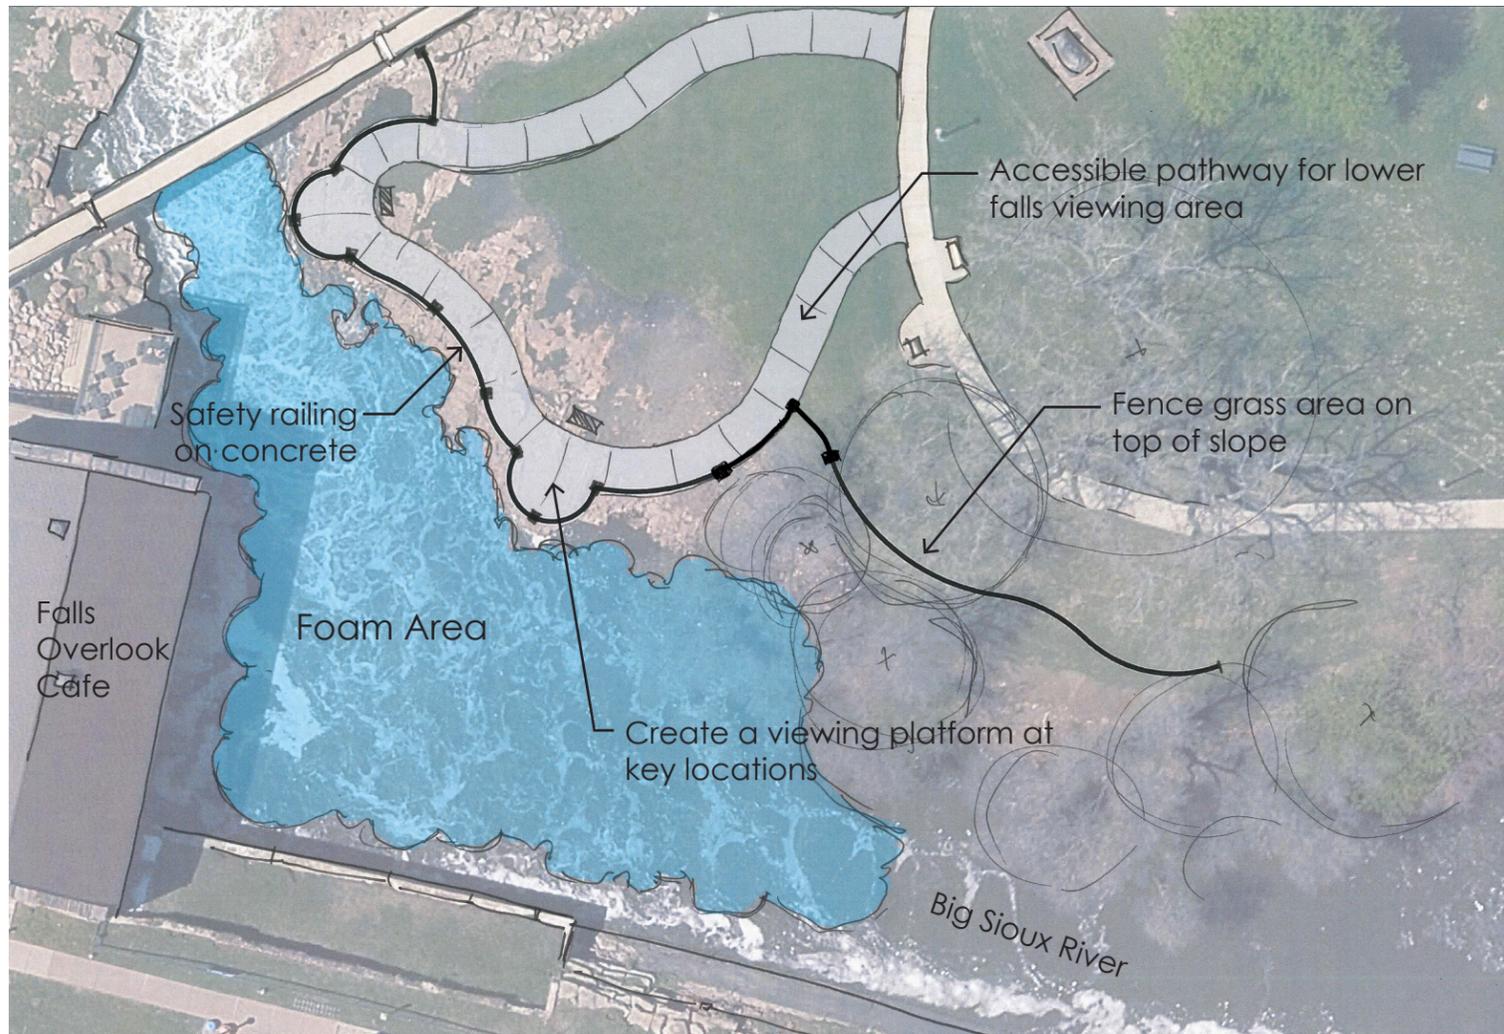
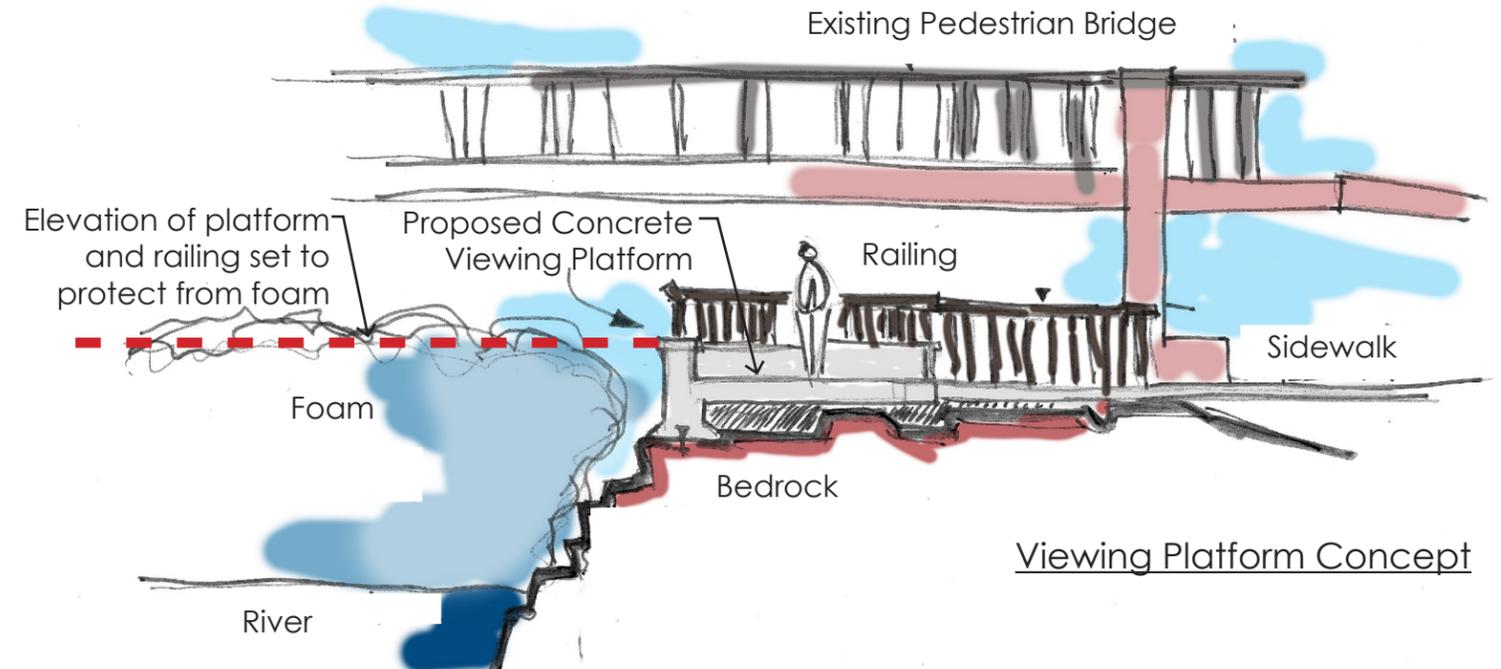
# Proposed Improvements (Safely Embrace the Situation)

- People are attracted to this area to view the natural beauty of the lower falls and the volume of water that flows through it.
- Create a safe way for visitors to experience the area, by constructing viewing platforms that include safety railing, accessible pathways, and warning signs.
- Utilize interpretive signage to inform people about the natural danger and history of this location.

The City should build a lower falls viewing area with an accessible pathway, two viewing platforms, and a safety railing. The viewing platforms and railing along the walkway would allow visitors to view the area of rapid water, including the foam when it builds up, while deterring them from being on the rocks. The proposed improvements are shown on Exhibit B. The grassy area with trees north of the improvements should also be fenced to deter visitors from walking or climbing on the rocks in that area. The estimated cost of the improvements is \$250,000 to \$300,000. Construction could be started in 2018 in time to be completed by April 1, 2019. The impacted area would be fenced during construction and not accessible until the project is complete.

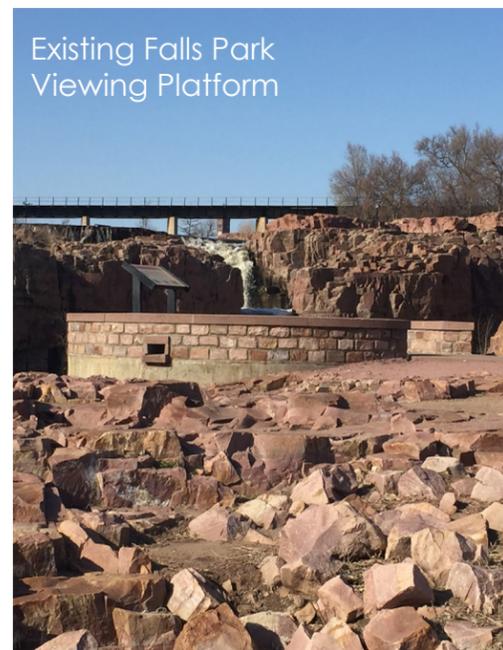
Existing Falls Park Viewing Platform

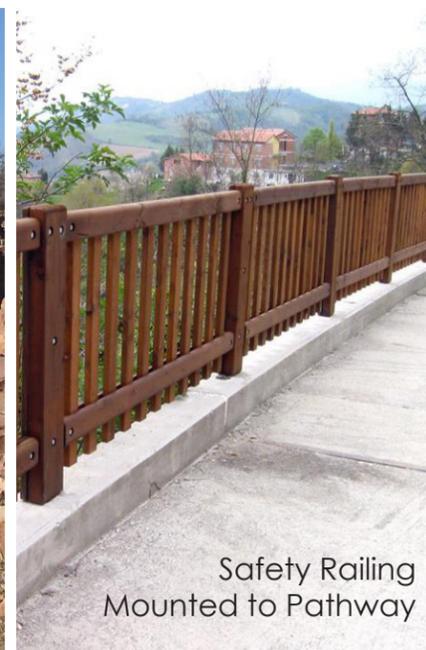
Safety Railing Mounted to Pathway
